Columbia Crew Survival Investigation Report

NASA/SP-2008-565

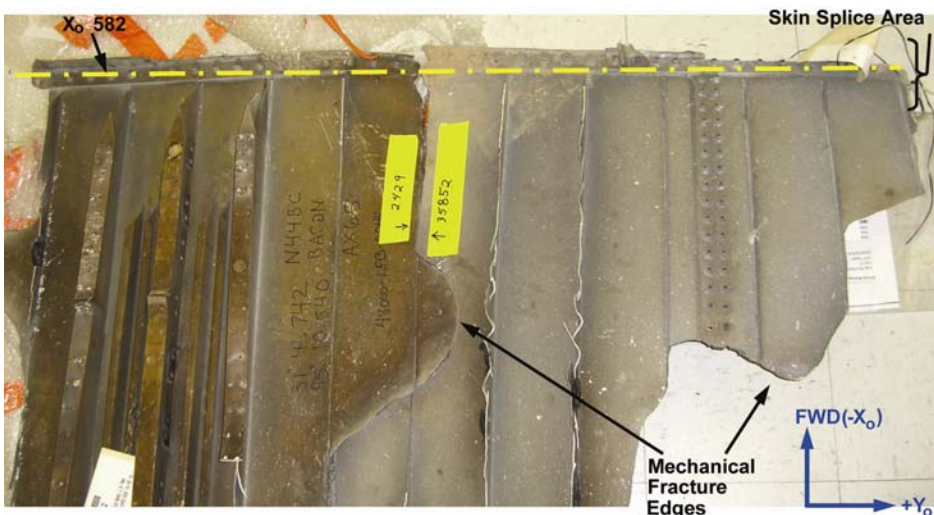
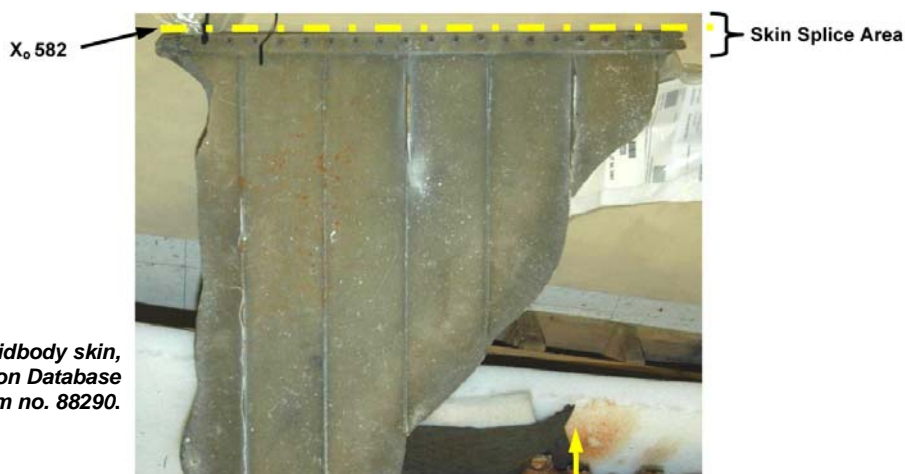
The recovered midbody bottom skin pieces from Bay 1 (the most forward bay in the midbody, immediately aft of the X₀ 582 ring frame bulkhead (figures 2.2-35, 2.2-36, and 2.2-37)) show little or no heat damage to the skin at the splice aft of the X₀ 582 ring frame bulkhead. The damage is mainly mechanical breakup of the frame to skin splice.

Figure 2.2-35. Bay 1 midbody bottom skin, Columbia Reconstruction Database debris item nos. 2429 and 33852.

Figure 2.2-36. Bay 1 midbody skin, Columbia Reconstruction Database debris item no. 88290.

Figure 2.2-37. Bay 1 midbody skin, Columbia Reconstruction Database debris item no. 14908.

The *Columbia* Reconstruction Team noted that thermal damage to the midbody was not generally severe.¹⁰ The thin skin and stringers of Bay 1 experienced some heating but not sufficient to melt the material. One scenario that may explain this is that this bay corresponded to the X location of the structural failure and disintegrated quickly during or immediately after the CE. Even if the bay skin remained with the midbody at the CE, without the X_o 582 ring frame bulkhead frame aerodynamic loads would peel off the Bay 1 skin quickly. This is consistent with the interpretation that the forebody and midbody separated in this area.

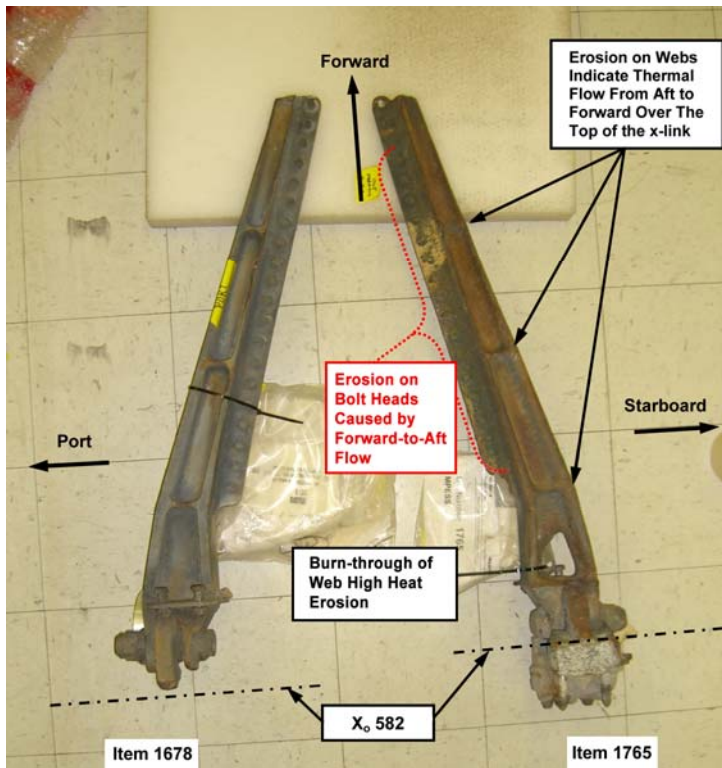
Figure 2.2-38. Port and starboard x-links.

Comparison of the recovered port and starboard x-links (figure 2.2-38) shows two important differences. First, the starboard x-link was recovered with a portion of the X_o 582 ring frame bulkhead and starboard sill attached, while the port x-link failed forward of the X_o 582 ring frame bulkhead. Second, the starboard x-link experienced much more thermal erosion than the port x-link. It is clear that the directionality of the thermal damage (aft to forward flows above the x-links, and forward to aft flows along the bolt heads) is the same on both links. This orientation was shown to be unlikely due to a common trim attitude when free-flying (see Section 2.1). This strongly suggests that they were in the same relative orientation (still attached to forebody structure) when exposed to heating. The common thermal pattern on the x-link body is discussed in Section 2.4.

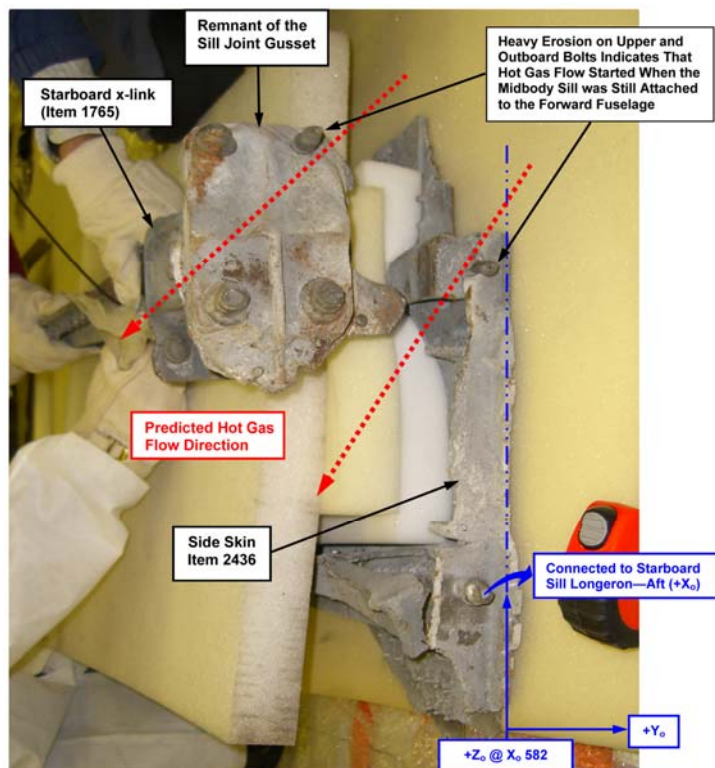
Figures 2.2-39 and 2.2-40 show the heavy thermal erosion on the sill joint gusset that is attached to the starboard x-link. The portion of side skin splice from just outboard of the starboard x-link was also recovered. Heavy heat erosion was noted on the midbody side (aft side of X_o 582 ring frame bulkhead), but was not significant elsewhere on the debris. This skin panel was recovered near the center of the forebody debris field. Together, this confirms that the CM stayed inside the FF shell until the forebody breakup, and suggests that the trailing edge (midbody side) was exposed to heating.

The structure aft of the X_o 582 ring frame bulkhead on both the starboard covering side skin and the starboard x-link was heavily damaged by heat. The heat erosion pattern on bolt heads on the aft side shows that the higher (+Z) and outboard (+Y) bolts experienced more heat erosion than the lower/inboard bolts. The resulting shape of eroded bolt heads indicates

Figure 2.2-39. View looking forward at the starboard x-link and side skin.

that hot gas flowed down and inboard (figures 2.2-39 and 2.2-40). This suggests that the aft side of the starboard x-link area was exposed to hot gas while the starboard midbody sidewall/sill was still attached to the X_o 582 ring frame bulkhead and FF.

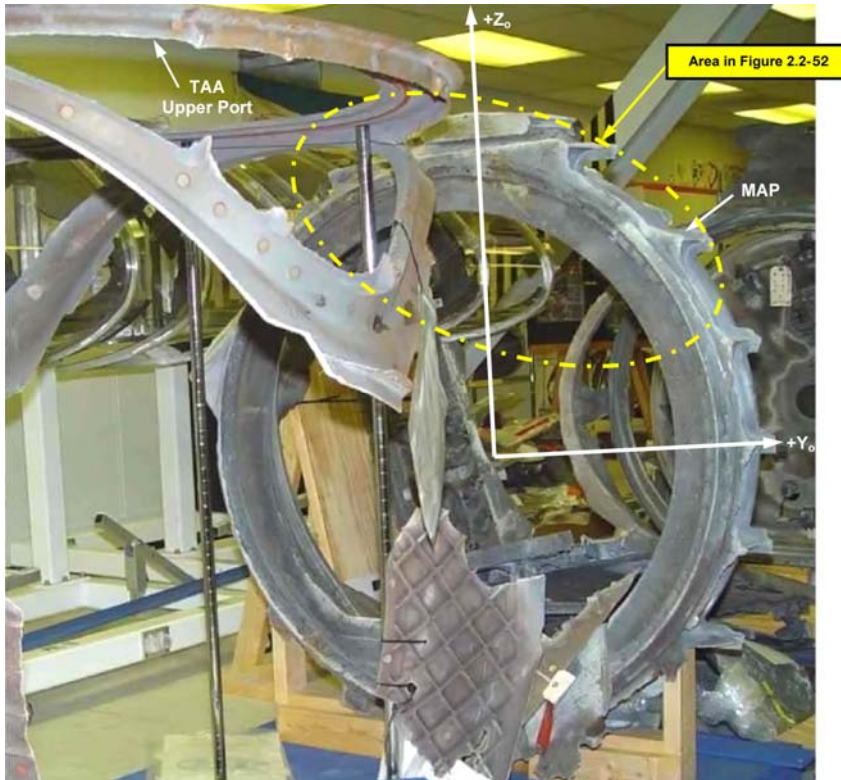
As shown in figures 2.2-51 through 2.2-54, the 12 high-strength bolts (180,000 pounds per square inch (psi)) that attached the forward ring of the TAA to the MAP failed with shanks still remaining in the inserts. This suggests that this area was subjected to high tension and bending while the remaining bolts were not subjected to the same loading. It implies that this TAA joint reacted to a bending moment (M_{TAA}) plus aft tension loading (figure 2.2-54). When the aft end of the TAA was restrained by the SPACEHAB tunnel to the midbody, the forebody yawing left and pitching down relative to the midbody could create the same bending effects. This suggests that the TAA broke away from the MAP when the forebody separated from the midbody at the CE or shortly afterwards.

Figure 2.2-51. Tunnel adapter assembly and the manufacturing access panel debris, view looking forward at "B" hatch opening.

Darker shading color on the surface of the MAP, as was noted on figures 2.2-51 and 2.2-52, indicates that this area was shielded by the missing portion of the TAA ring and suggests that the MAP surface outside of the TAA ring was subjected to thermal flow before the TAA departure. If the TAA departed at the CE, the MAP or the aft bulkhead of the CM was exposed to the thermal flow for some period of time prior to the CE (figure 2.2-44). This would agree with the theory that the PLBDs were compromised prior to the CE.

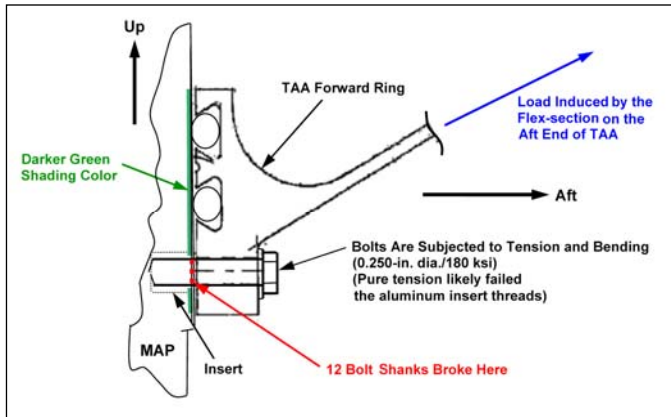
Figure 2.2-53. Cross section through tunnel adapter assembly mounting bolt.

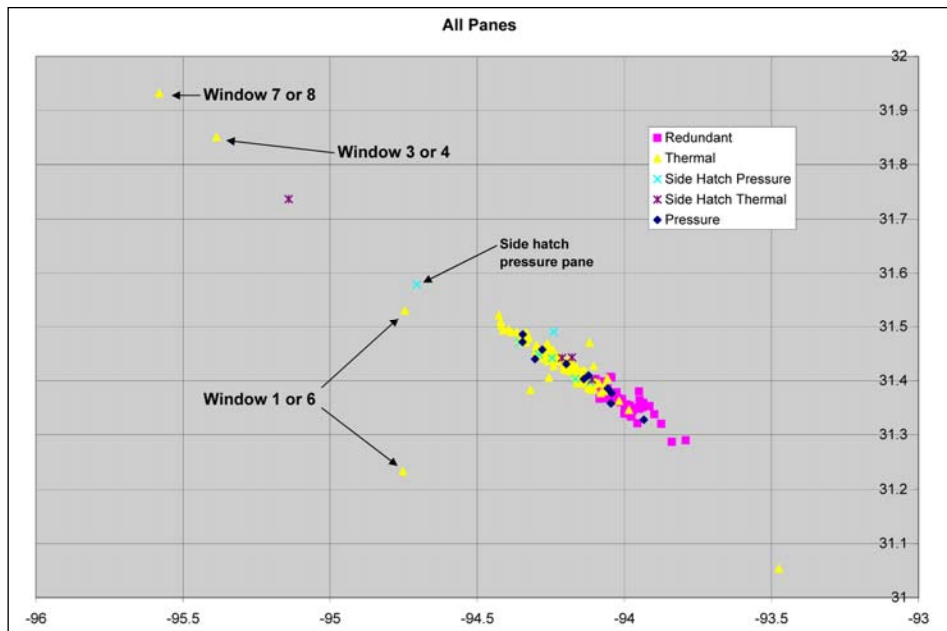
Figure 2.4-8. Recovered debris field for window glass.

A different concern was whether the flexing of the structure under the varying loads at the LOC and the CE would cause the glass to shatter. The debris field analysis refuted that theory as well. Figure 2.4-8 shows the debris field coordinates for recovered glass.

Of the 201 recovered glass fragments, only six pieces of loose glass that are confidently believed to be from the orbiter were found west of the main forebody debris field. All were thermal (outer) panes with the exception of one piece of probable side hatch pressure pane. However, a piece of pressure pane that was recovered in the western end of the debris field does not alone indicate a source of depressurization. Pressure panes may be damaged due to objects moving around inside the CM as it rotated, impacting the windows. If the cabin is depressurized from a different source, these pieces can evacuate through other breaches.

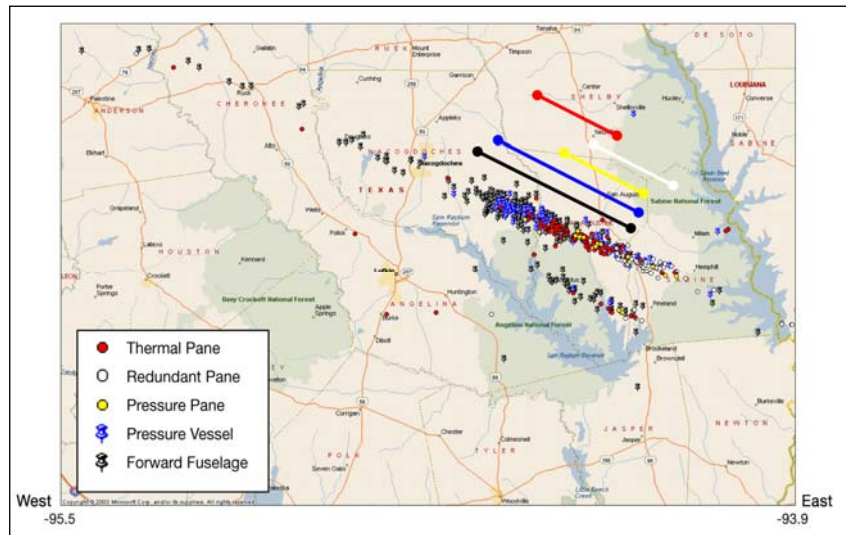
Figure 2.4-9. Debris field of the window panes, forward fuselage, and crew module pressure vessel.

If the source of the cabin depressurization had been a window, both the pressure pane and the redundant pane would have to have failed. However, redundant pane is not seen until the far eastern end in the forebody debris field. Also, in such a case, the pressure from inside the CM would likely blow the entire pane out and result in significant amounts of glass that were not seen west of the main forebody debris field.

Figure 2.4-9 shows that thermal pane debris was recovered east of the beginning of the main forebody debris, suggesting that the windows broke at or after the CMCE. Pressure panes were recovered west of the bulk of the redundant panes, possibly because the redundant panes were extraordinarily thick and heavy and may have traveled farther east because their ballistic number was higher. Determining the failure sequence of the windows based on ground plots alone was somewhat suspect because some of the window frames remained attached to other window frames as a unit, and the shape of the windows can potentially generate lift. Regardless, because the debris field does not contain significant pane debris west of the main CM debris field, it is concluded that the windows were not the source of a CM breach or a part of the initiating event of the forebody breakup.

Finding. The *Columbia* windows remained largely intact up until the CMCE and were not a cause of cabin depressurization.

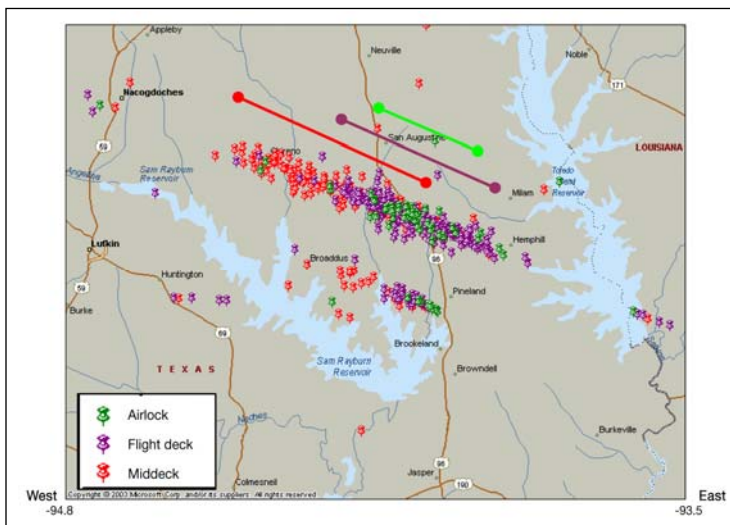
Figure 2.4-17. Debris field of the middeck, flight deck, and airlock.

The internal airlock is structurally attached to the CM aft of the X₀ 576 bulkhead. It likely stayed with the aft bulkhead after the middeck departed. Figure 2.4-17 indicates that the airlock structural debris is also squarely in the middle of the flight deck structural debris. This suggests that the flight deck and airlock remained connected to each other by the aft bulkhead.

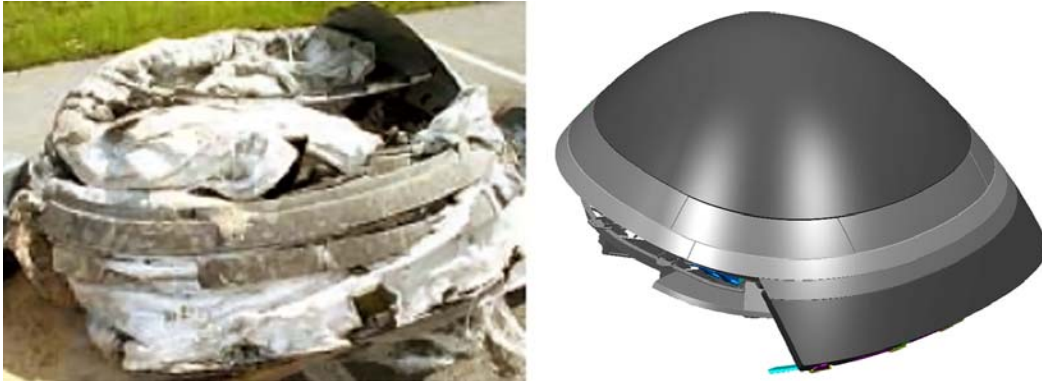
The recovered FF components are predominantly skin/stringer segments. Most components exhibited mechanical overload as the primary failure mechanism. Roughly 40% of the FF was recovered with no difference in damage levels comparing left to right or upper to lower. Two recovered RCC components, the nose cap and the chin panel (figure 2.4-23), show evidence of mechanical breakup with low thermal damage. It should be noted that the nose cap, based on field reports, apparently hit a tree before hitting the ground. The presence of intact Koropon primer on many FF components indicates that significant heating did not occur. Temperatures above 400°F (204°C) degrade the primer’s appearance, and high temperatures

(>900°F) (486°C) will completely ablate it. The presence of Koropon indicates that the breakup of these elements was caused by mechanical overload rather than thermal effects.

Figure 2.4-23. Nose cap Columbia Reconstruction Database debris item no. 1114 vs. the original nose cap with chin panel.

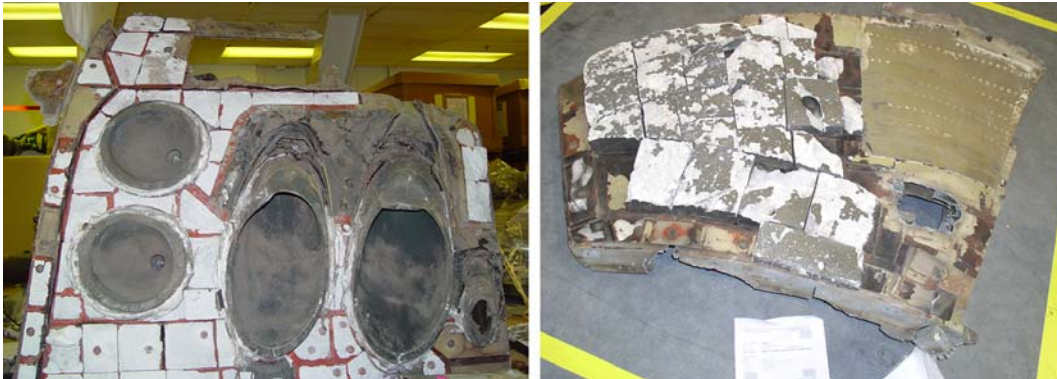
Some large pieces of the forward RCS were recovered (figure 2.4-24). These exhibit evidence of mechanical overload as the primary failure mechanism. Heating did not appear to play a significant role in the component degradation and appears to have occurred during or subsequent to the mechanical breakup.

Figure 2.4-24. Two large forward Reaction Control System debris pieces, Columbia Reconstruction Database debris item nos. 792 (left) and 82061 (right).

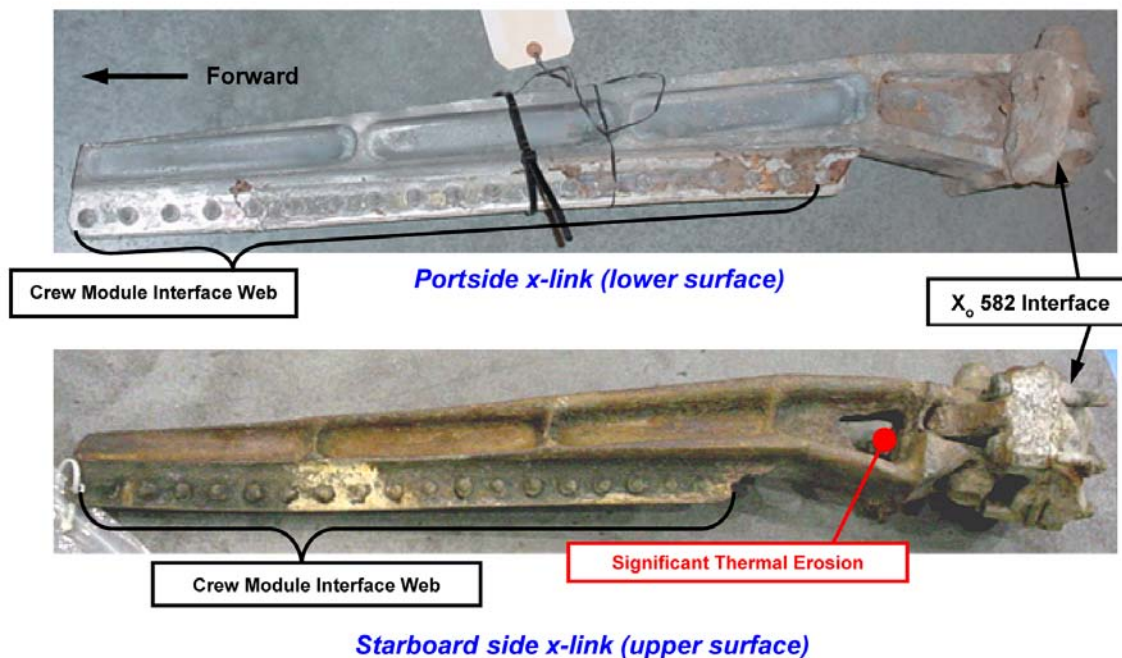
Both the port and the starboard x-links (figure 2.4-25) were recovered nearly intact with evidence of high heating. The titanium fittings on both links experienced significant thermal exposure/melting, predominantly on the upper surfaces. Additionally, the starboard side fitting experienced significantly greater heating and erosion than the portside.

Figure 2.4-25. Crew module x-links, Columbia Reconstruction Database debris item nos. 1678 (top) and 1765 (bottom).

The titanium x-link components did not fail. The attach area on the CM side of the x-link is stronger than the FF side since it is reinforced by the flight deck floor and the X_o 576 bulkhead. The failures occurred at the weaker X_o 582 ring frame bulkhead connection points. The port x-link experienced a mechanical lug failure at the X_o 582 ring frame bulkhead interface, while the starboard side fittings pulled through the X_o 582 ring frame bulkhead at the CE. The starboard x-link retained some of the sill and X_o 582 ring frame bulkhead while the portside did not. Furthermore, it was concluded that at the CE, the forebody rotated left and pitched down, separating from the midbody (see Section 2.2.4).

Heat damage patterns on the webs of both x-links indicates that, at some point, there was hot gas flow from aft to forward above both x-links. The starboard x-link has more damage than the port x-link. Thermal analysis (see Section 2.1.6.7) of the x-links shows that entry heating alone was not capable of causing such heavy erosion. Additionally, because the surrounding structure was aluminum with a much lower melting temperature, entry heating alone would have resulted in the weakening of the surrounding structure first and release of the x-links. Section 2.1.7 discusses the other thermal mechanisms that were likely involved, shock-shock interactions and combustion. Both of these mechanisms are possible with the forebody geometry as understood from the debris.

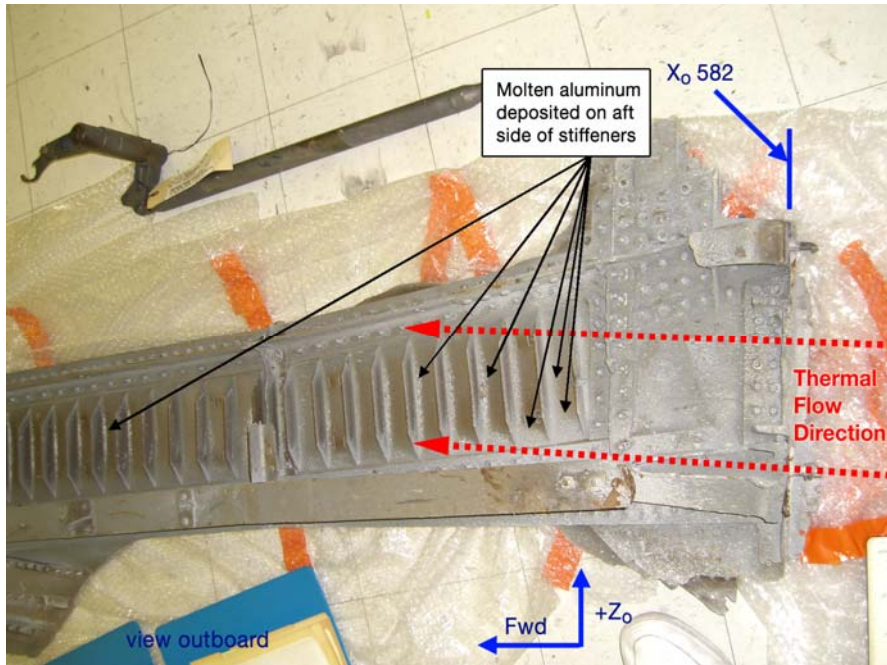
Figure 2.4-27. Inboard side of the starboard-side skin, Columbia Reconstruction Database debris item no. 2436.

This debris shows high heat erosion at the aft end while the remaining edges failed mechanically. The pattern of molten aluminum deposition indicates that the hot gas flowed mainly from aft to forward. If the thermal event happened after this panel broke away from the FF shell, all edges should experience a similar level of thermal damage, and the deposition of molten aluminum on the inside surface of the skin should have a random pattern instead of a directional pattern (figure 2.4-27). This suggests that this piece of FF skin was in place when the thermal event occurred. It is not known when this thermal event occurred. Since the forebody was rotating, the aft portion of the forebody may have periodically been presented to thermal flow for brief periods between the CE and the CMCE. The thermal event may also have happened around the CMCE, when the FF pulled away and exposed the area to thermal flow.

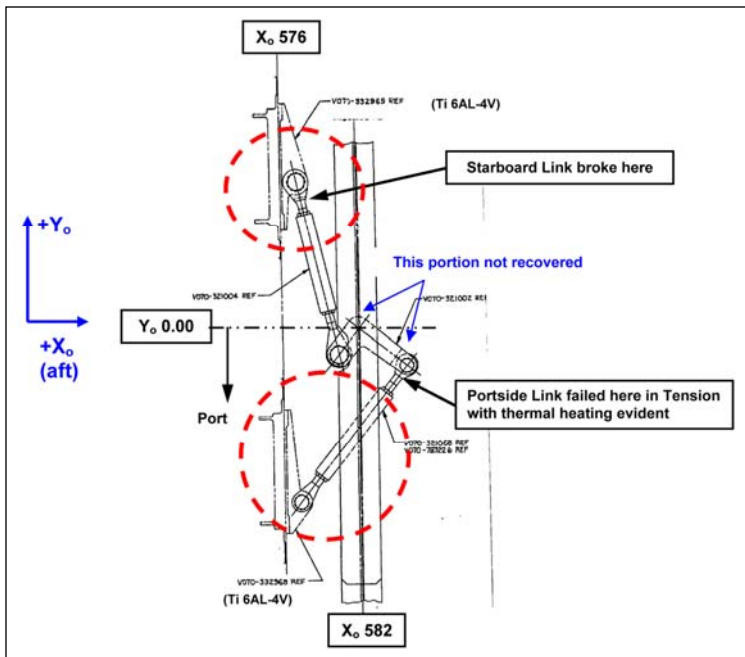
The y-links attach the aft bulkhead of the CM (X_o 576) to the X_o 582 ring frame bulkhead at the lower central portion of the bulkhead. It is possible that the two y-links remained intact at the CE, since most of the X_o 582 ring frame bulkhead is believed to have stayed with the FF. After the CE, any Y-direction movement of the CM relative to the X_o 582 ring frame bulkhead would exert high tension or compression loads on these links. Failure by tension is evident on the recovered debris of these links. The portside y-link shows that it also was softened by thermal exposure along with the tension failure. This portion protrudes beyond the X_o 582 ring frame bulkhead, which would have been exposed periodically to hot gas flow following the CE as the forebody rotated (figures 2.4-28 and 2.4-29).

Figure 2.4-28. View looking from the top at the y-links.

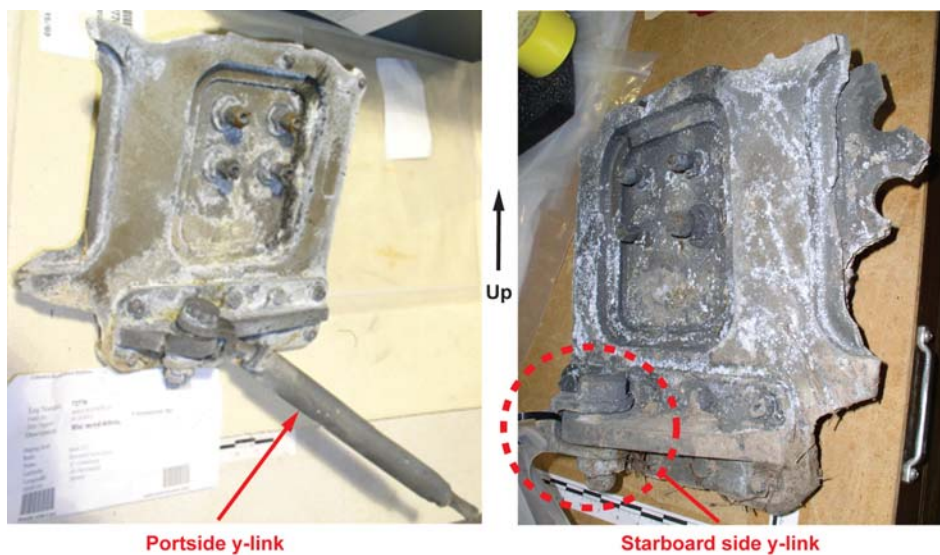
Figure 2.4-29. The y-link debris, still attached to the mounting on the X_o 576 bulkhead, Columbia Reconstruction Database debris item nos. 72770 (left) and 9280 (right).

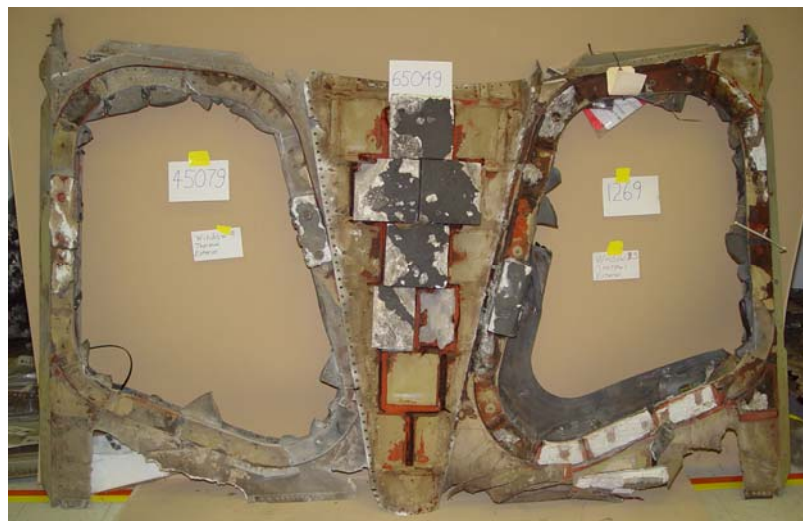
The “arrowhead” skin/TPS panel between Windows 3 and 4 (debris item no. 65049) (figures 2.4-38 and 2.4-39) on the front of the forebody was recovered near the middle of the forebody debris field. It appears to have been torn on the portside and pulled through on the starboard side by mechanical loading, probably initiated by a relative movement between the port Windows 1 through 3 and the starboard Windows 4 through 6.

Figure 2.4-38. Forward fuselage arrowhead panel and the forward two windows, facing in.

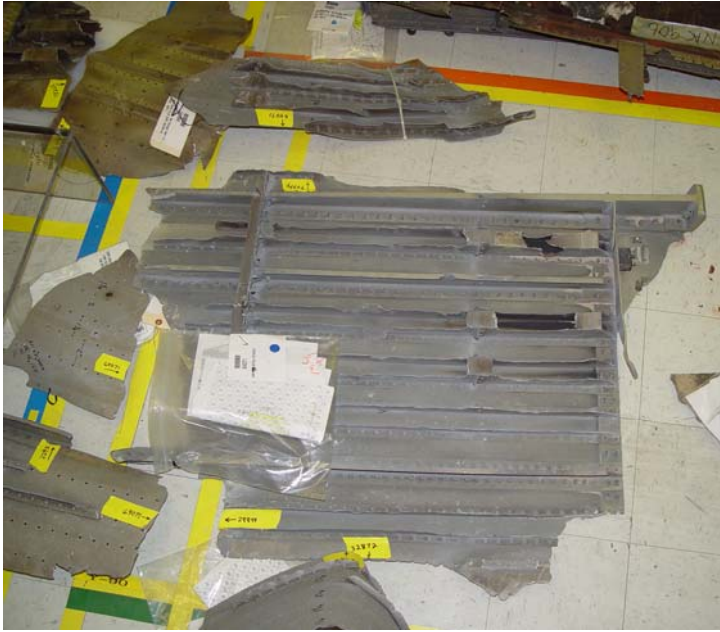
Figures 2.4-40 and 2.4-41 are of the FF skin debris items that lie below the CM. Many panels have little molten metal deposition on the inside surfaces. Broken edges show little thermal damage, and some still have intact primer. This indicates that the plenum behind these areas was not exposed to long durations of thermal flow. Some skin pieces even had stringers that were removed mechanically. Most of the recovered skin debris appears to have mechanically fractured edges. Many forward RCS structural items were recovered; it appears that the forward RCS was pulled away mechanically and broke up into pieces with low thermal effects. The conclusion was that it is likely that the FF skin panel peeled away and broke up quickly.

Figure 2.4-41. Lower forward fuselage skin panel near external tank attachment.

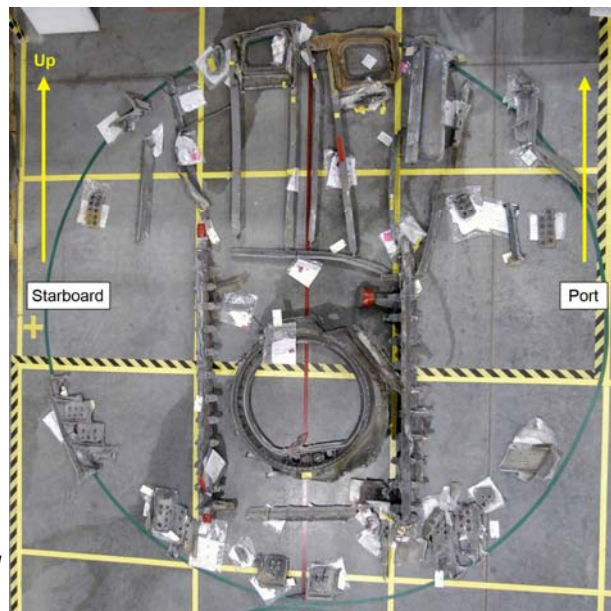
In general, heavy portions of the X_o 576 bulkhead (including the MAP) survived the entry heating (figure 2.4-46). This is possibly due to the high heat absorption property of the aluminum bulkhead.

Some “T”-section stiffeners survived with little heat damage, possibly because of the early departure of these elements before the high thermal event that consumed the bulkhead.

Figure 2.4-46. View looking aft of the recovered X_o 576 bulkhead debris.

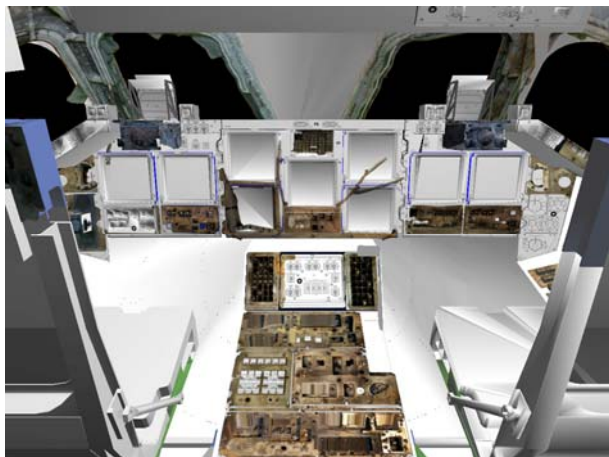
Figure 2.4-56. Virtual reconstruction of the recovered Columbia flight deck panels.

This virtual reconstruction was studied to investigate whether there were clear indications of a thermal or structural breach. However, adjacent panels were seen to have received significantly different amounts of thermal damage. This indicated that some panels broke off earlier than other panels, or were temporarily shielded from the thermal flow during the breakup. The damage varied greatly from one panel to the next, indicating a chaotic breakup sequence. No clear evidence of the initial breach location could be determined.

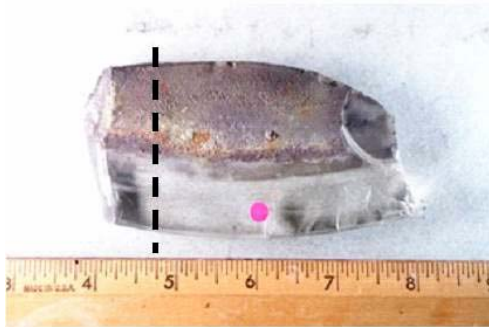
Figure 2.4-60. Window fragment removed from the thermal pane frame from Window 8. The black dashed line denotes the sectioning plane. The red dot was used to indicate the outward face of the pane.

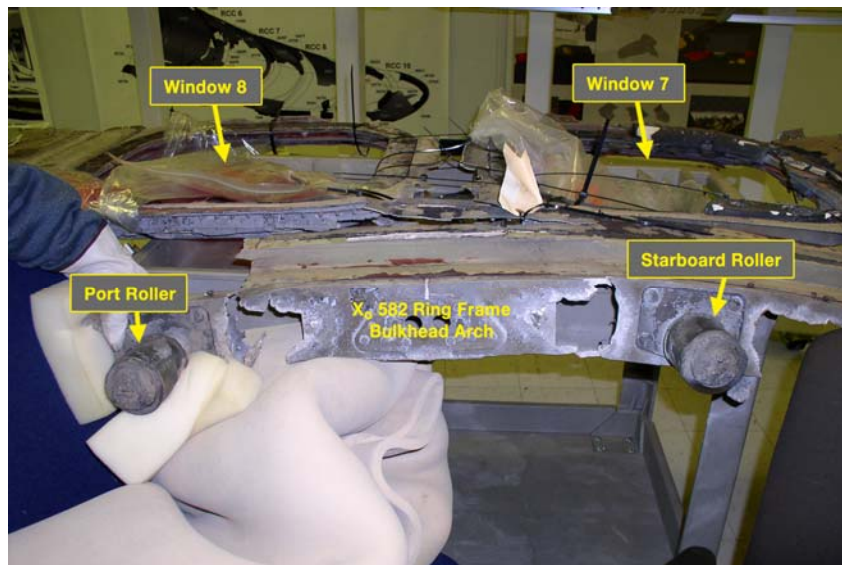
Figure 2.4-63. Columbia debris for same location. Note eroded rollers and eroded region of the X, 582 ring frame bulkhead arch between the rollers.

The recovered rollers for the location closest to the overhead windows both showed significant signs of erosion. While these rollers were not the only components made of titanium, they were the only ones recovered that possessed the proper material, proximity, and thermal indications and were, therefore, concluded as the source location. Given these findings, the rollers were the most probable source of titanium causing the deposition on the windows.

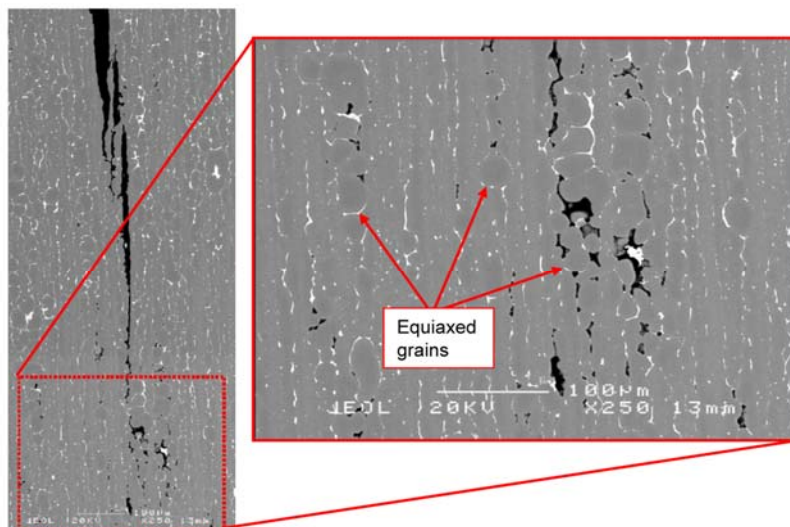
Figure 3.1-17. Scanning electron microscope image of broom-straw fracture surface cross sections.

Scanning electron microscope analysis of the seat broom-straw fracture surface cross sections revealed fully intergranular fractures and equiaxed grain⁸ microstructure. This finding is consistent with exposure to elevated temperatures and high strain rates. Equiaxed grains were discovered both along and away from the crack surfaces (figure 3.1-17).

Metallurgical evaluation was completed in proximity to, and away from, the crack surfaces using energy dispersive X-ray spectroscopy. This revealed heavy grain boundary precipitation that is consistent with the aluminum alloy experiencing temperatures greater than 900°F (482°C).

All of these features are consistent with material that is exposed to high temperatures. Significant lack of ductility surrounding the fracture areas indicates that the failures occurred at relatively high strain rates.

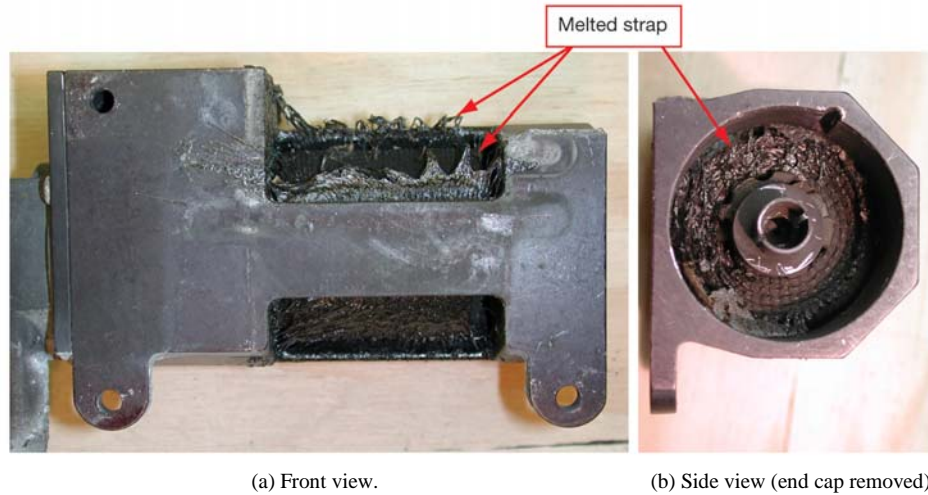
Figure 3.1-23. *Inertial reel melted strap material.*

In all cases, the inertial reel straps were melted only in areas that were immediately adjacent to the strap pass-through openings and along the lateral edges of the strap (figure 3.1-23). The strap material in other areas was not melted and appears normal.

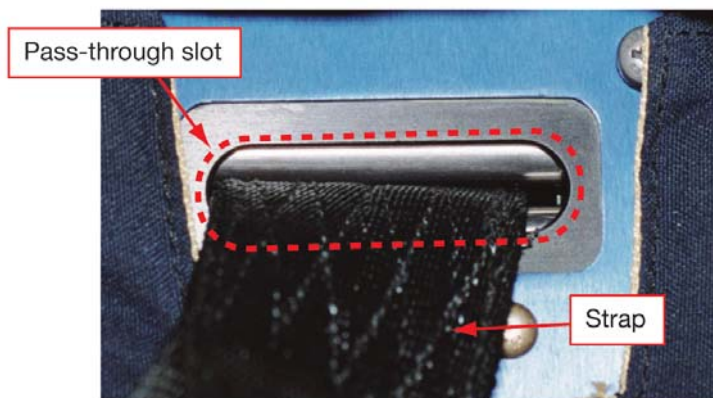
Figure 3.1-27. Seat strap pass-through slot (intact seat shown). [Picture from a shuttle training mockup in the JSC Space Vehicle Mockup Facility]

six recovered inertial reel straps. This failure is similar to a failure mode known as strap “dumping.”¹² It is theorized that loading of the inertial reel strap laterally against the pass-through slot (figure 3.1-27) resulted in damage to the strap and, eventually, strap failure.

Finding. The seat 2 inertial reel strap exhibits “strap dumping” failure features. The strap failed progressively, possibly due to damage to the lateral edge of the strap from contact with the sharp edge of the strap pass-through slot.

Recommendation L2-5. Incorporate features into the pass-through slots on the seats such that the slot will not damage the strap.

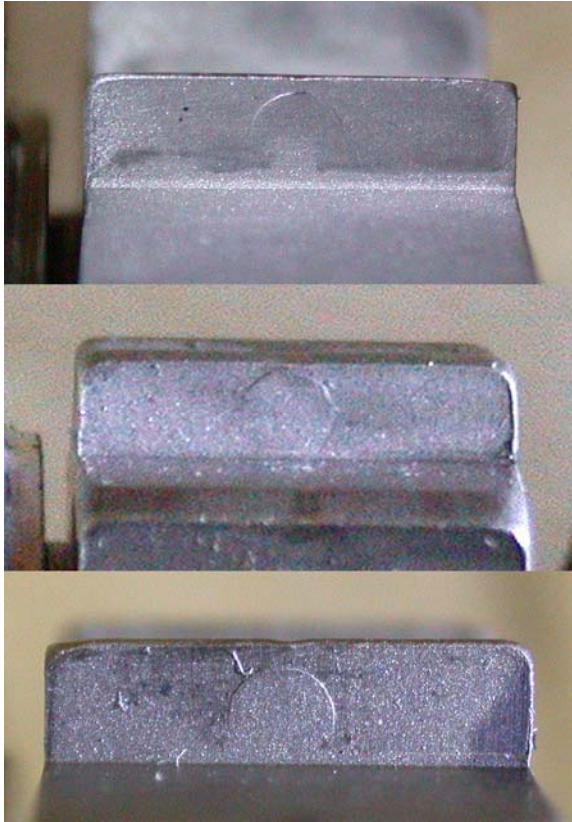
It was initially thought that the witness marks were an indication of inertial reel strap loading during the accident. However, extensive investigation of inertial reels from training seats and other flown shuttle seats as well as a new inertial reel revealed identical circular witness marks (figure 3.1-34).

Figure 3.1-34. Circular witness marks on inertial reels from a training seat (top), a flight (non-Columbia) seat (middle), and a new (unused) flight-qualified inertial reel (bottom).

All inertial reels/straps of this type are proof-tested by the manufacturer with a 3,350-lb. static load prior to delivery to the customer. Because these inertial reels (and the *Columbia* inertial reels) were proof-tested, the investigation concluded that the witness marks on all of the inertial reels are a result of proof-testing. The absence of a second witness mark on the inertial reel led to the conclusion that the inertial reel straps failed at forces below the equivalent of a 3,350-lb. static load. However, it is probable that the straps failed under dynamic loading. As discussed above, the straps' load-carrying capabilities under dynamic loading are unknown.

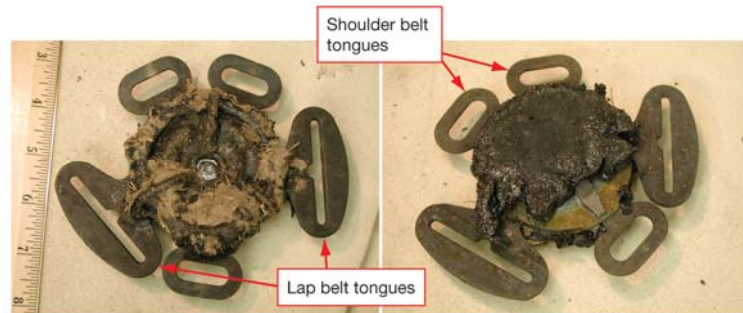
Figure 3.1-40. *Recovered five-point seatbelt buckle (front and back).*

One of the seven 5-point seatbelt buckles on board *Columbia* was recovered (figure 3.1-40). Positive identification to a seat position was not possible. Although the buckle experienced significant entry heating, resulting in substantial melting of the outer plastic housing, the structure remained intact with all five belt tongues still in place.

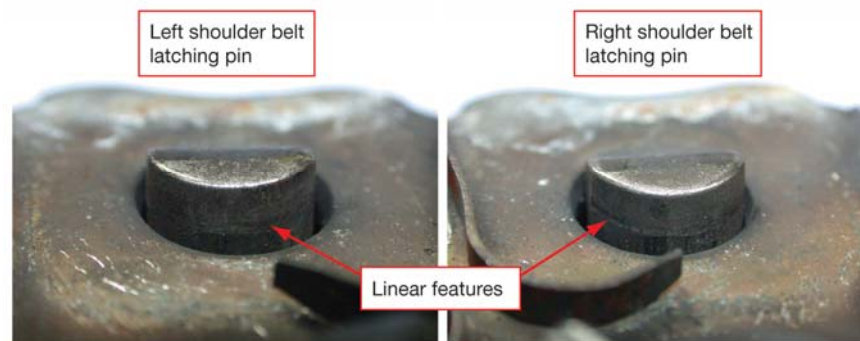
The buckle assembly was disassembled for analysis. The two shoulder belt tongues and the two lap belt tongues were bent outward slightly (i.e., away from the crew member). Both of the shoulder belt tongue latching pins had very shallow linear features corresponding to the mating surfaces of the belt tongue (figure 3.1-41). These features may be witness marks as a result of dynamic loading events that were experienced in flight by the restraint system or of forces imparted to the five-point attach buckle during disassembly by the CAIB investigation team. A definitive conclusion cannot be made based on these witness marks alone. The other latching pins did not exhibit any noticeable marks or deformations.

Figure 3.1-41. *Indentations on latching pins, looking from center of buckle towards outer edge.*

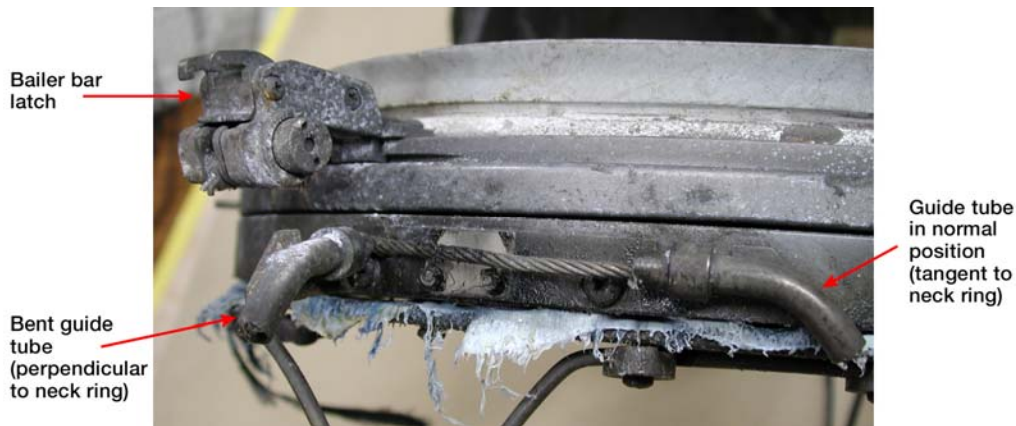
The hold-down cables on each neck ring were severed at the attach points to the cable guide tubes due to mechanical overload (figure 3.2-24). Most cable guide tubes experienced significant plastic deformation. The guide tubes display evidence of external contaminants (i.e., melted metal and suit material) and thermal effects on top of the fractures and localized deformation. This indicates that mechanical loading preceded exposure to the thermal environment. Rotation of the helmet relative to the normal forward position was observed on all neck rings varying from 90 to 180 degrees. Major cable guide tube deformation and helmet rotation indicates that a significant loading event occurred where helmets were removed via a mechanical (nonthermal) mechanism.

Figure 3.2-24. Hold-down cable guide tube.

The bailer bar latch mechanisms on five of the seven helmets remained attached to the helmets in good condition (figure 3.2-24). This would not be expected if the crew members had lowered and locked their visors. Mechanical separation of the bailer bar would be accompanied by fracture of the latch assembly if the visor was down and the bailer bar was locked. The other two helmets experienced latch mechanism separation due to failure of the fasteners that attach the latch mechanism to the helmet before subsequent deposition of melted suit materials. This suggests that latch separation was followed by suit melting. Neither of the two helmets shows evidence of the indentation or deformation that would be associated with forces expected if the bailer bar ripped the latch from the neck ring. Combined with the absence of melted visor material on the visor seal, this confirmed the conclusion that none of the crew members lowered and locked visors.

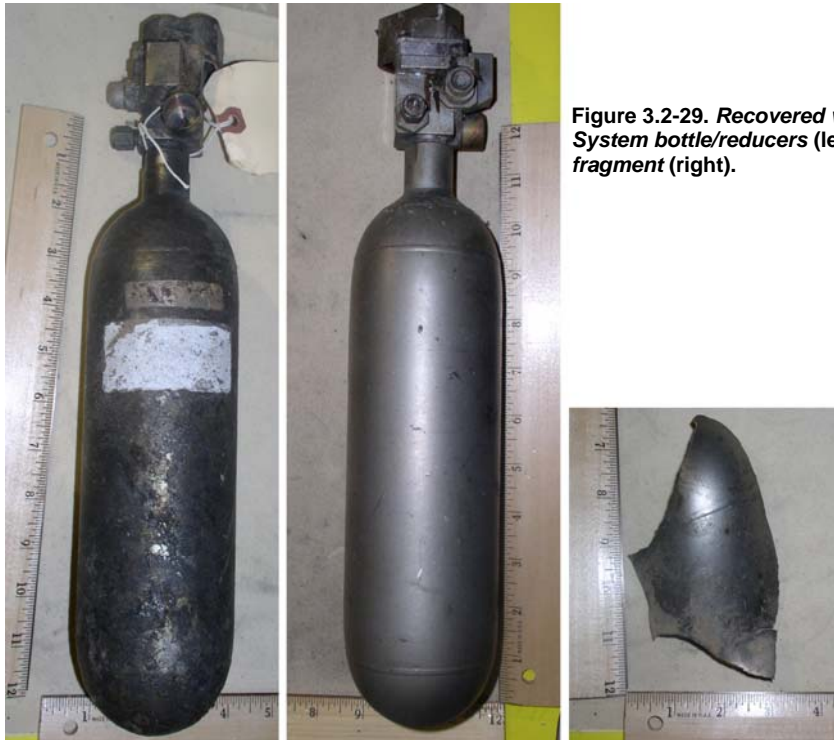
Ten whole EOS bottle/reducers were recovered (eight were ascribed to specific crew members), each with no O₂ remaining. All 10 of the recovered EOS bottle/reducers have similar appearances, with some variance in the amounts of material deposition. Additionally, three fragments of bottles were also recovered (figure 3.2-29).

Figure 3.2-29. Recovered whole Emergency Oxygen System bottle/reducers (left and center) and a bottle fragment (right).

No nylon material from the parachute harness adhered to the bottle/regulator assemblies. Minor evidence of elevated temperatures, directional burn marks, and discrete external impacts are visible. As with most of the *Columbia* hardware, corrosion that occurred while the debris was on the ground is also evident. X ray revealed that all of the EOSs were activated. However, the crew members were trained not to activate them unless their visors were down. Therefore, activation of the EOS (achieved by applying tension to the activation cables) probably occurred as the bottles separated from the harnesses rather than by crew action.

The EOS bottle fragments exhibited irregular edges along the fracture surfaces, some outward bent edges, evidence of heating on the inner surfaces, and some deposited/flowed black material along a fracture surface.

Heating on the inner surfaces indicates that the bottle failure occurred before the end of entry heating. Neither the cause of the bottle failures nor the status of the bottles at the time of failure (pressurized or unpressurized) could be determined.

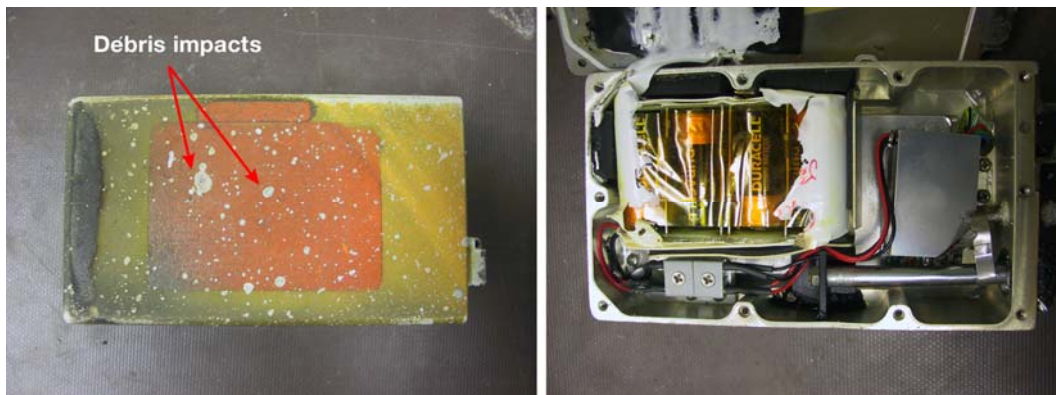
One TSUB-A SARSAT beacon is flown per crew member; it is located in the survival raft packed in the PPA. Six SARSAT beacons were recovered; none of them were activated during the accident. All six recovered SARSAT beacons show similar thermal and mechanical damage (figure 3.2-32).

Figure 3.2-32. External (left) and internal (right) views of a recovered search and rescue satellite-aided tracking beacon.

No material from the raft or the PPA was adhered to the outer aluminum casing. Various amounts of paint remained, displaying evidence of impacts with small, hot metal pellets. Corrosion was also present. All external plastic was melted. Internal inspection of the beacons revealed minor solder re-flow, with most of the components mechanically and electrically intact. Two SARSAT beacons were tested and, when externally powered, functioned properly. For each of the six SARSAT beacons, the processing module was extracted and interfaced with ground support equipment to read the beacon's unique identifier, thereby allowing all six beacons to be ascribed to individual crew members. Each SARSAT beacon was mechanically extracted from the PPA as temperatures were rising; then for a short duration and nearly simultaneously, it experienced high heating and a hot metal pellet-like shower. This indicates a rapid disruption of the parachute packs and release of the SARSAT beacons while they were still in close proximity to the CM debris cloud.

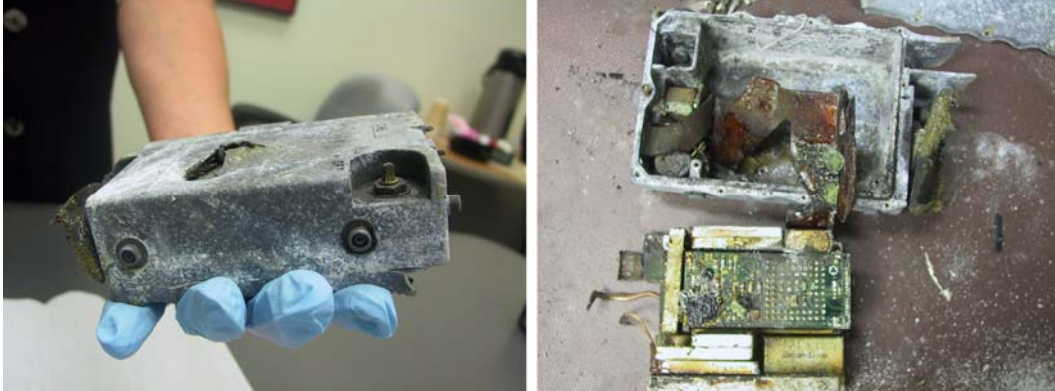
Four A/N PRC-112 radios were recovered, all of which looked similar (figure 3.2-33). No Nomex material from either the suit pocket or the survival gear pouch was adhered to the outer aluminum casing. Various amounts of paint showed evidence of impact with small, hot metallic pellets. Corrosion was also present. All external plastic was melted or missing. Internal inspection of the radios revealed evidence of moderate heating, with the center-most components experiencing only minor solder re-flow. For each of the four radios that were recovered, the control module was extracted and interfaced with ground support equipment to read the unique identifier of the radio. Thus, all four radios were ascribed to a specific crew member. Overall appearance suggests that each A/N PRC-112 radio experienced similar thermal and mechanical environments. Each radio was mechanically extracted from the ACES pocket and the survival gear pouch as temperatures were rising and, for a short duration and nearly simultaneously, each of the radios experienced high heating and a hot metal pellet-like shower. This indicates a rapid disruption of the suit survival gear pockets, releasing the radios while they were still in close proximity to the CM debris cloud.

Figure 3.2-33. External (left) and internal (right) views of a recovered Army/Navy personal radio communications-112 radio.
